Investigation of Steel-Stringer Bridges: Superstructures and Substructures, Volume II

Final Report
October 2007

Sponsored by
the Iowa Highway Research Board (Project TR-522)
and the Iowa Department of Transportation (CTRE Project 04-184).

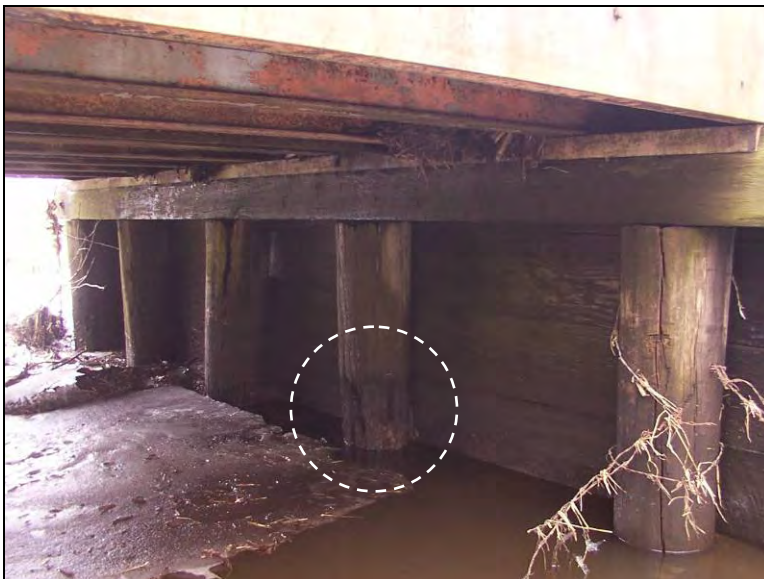
Figure 4.3. Reduction of pile cross section by abrasion from flowing debris and ice (Bridge No. 27-74-23 – February 15 2007)

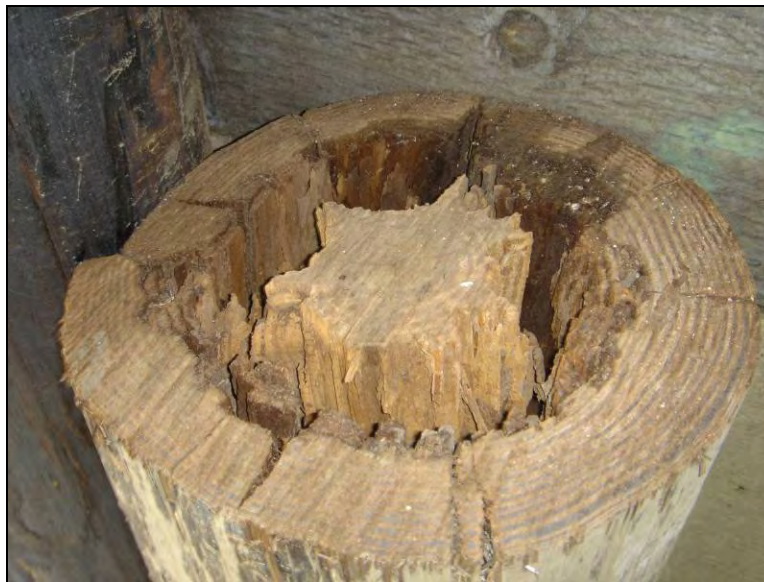
An example of a deteriorated pile is shown in Figure 5.1. The rapid attenuation of the wave in the hollow region hindered the detection of the intact area near the pile core and prevented the wave from reaching the receiving transducer.

Figure 5.1. Significant internal pile deterioration that is difficult to detected using the stress wave technique (Bridge No. 31-72-50 Tama County – June 10 2005)

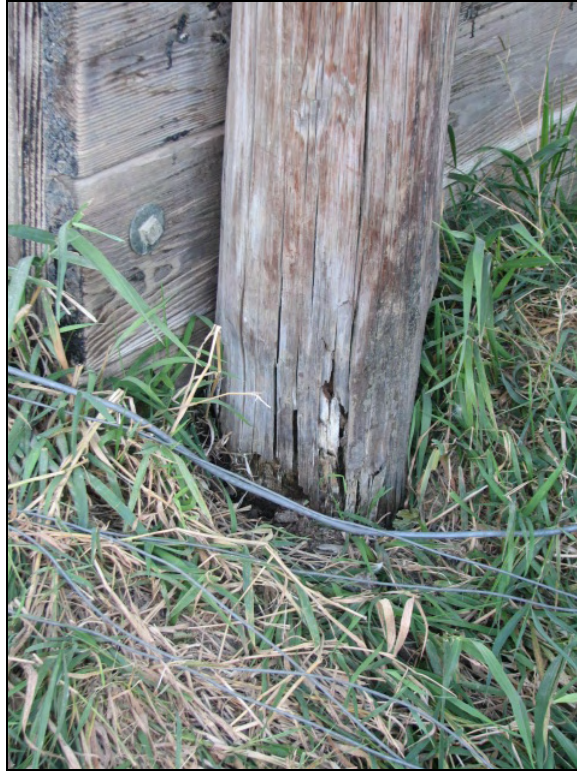
Figure 9.4. Biological deterioration of pile No. 1 at the ground level (Bridge No. 237350 Mahaska County – October 25 2005)

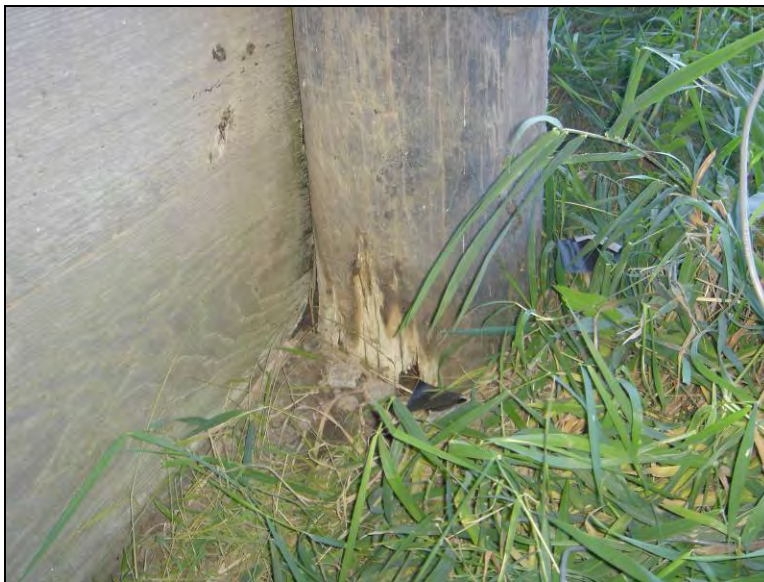
The south abutment, shown in Figure 9.6, has an average exposed pile length of about 94 inches and an average pile spacing of 49 inches. The tie back rods are about 6.5 ft from the pile heads. Figure 9.7 is a schematic diagram of the south abutment illustrating the exposed pile lengths and spacing. Visual observation revealed brooming in pile no. 2 near the ground level as shown in Figure 9.8. For pile no. 5, rotting near the ground level was observed (See Figure 9.9).

Figure 9.9. Rotting observed at pile No. 5 (Bridge No. 237350 Mahaska County – October 25 2005)

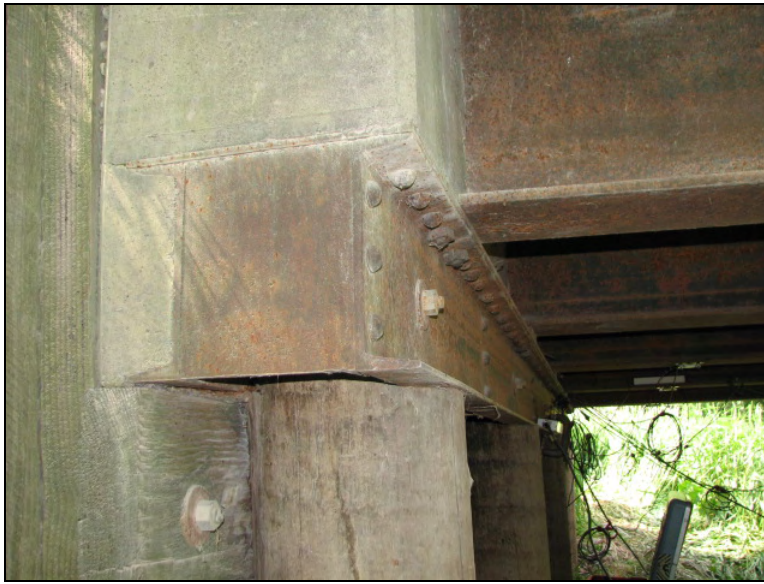
Figure 11.15. Partial bearing of the pile cap on the southeast abutment backwall (Bridge No. 237380 Mahaska County – May 27 2006)
